# **Debris/Ice/TPS Assessment and Integrated Photographic Analysis of Shuttle Mission STS-101**

**DEBRIS/ICE/TPS ASSESSMENT  
AND  
INTEGRATED PHOTOGRAPHIC ANALYSIS  
OF  
SHUTTLE MISSION STS-101**

**19 May 2000**

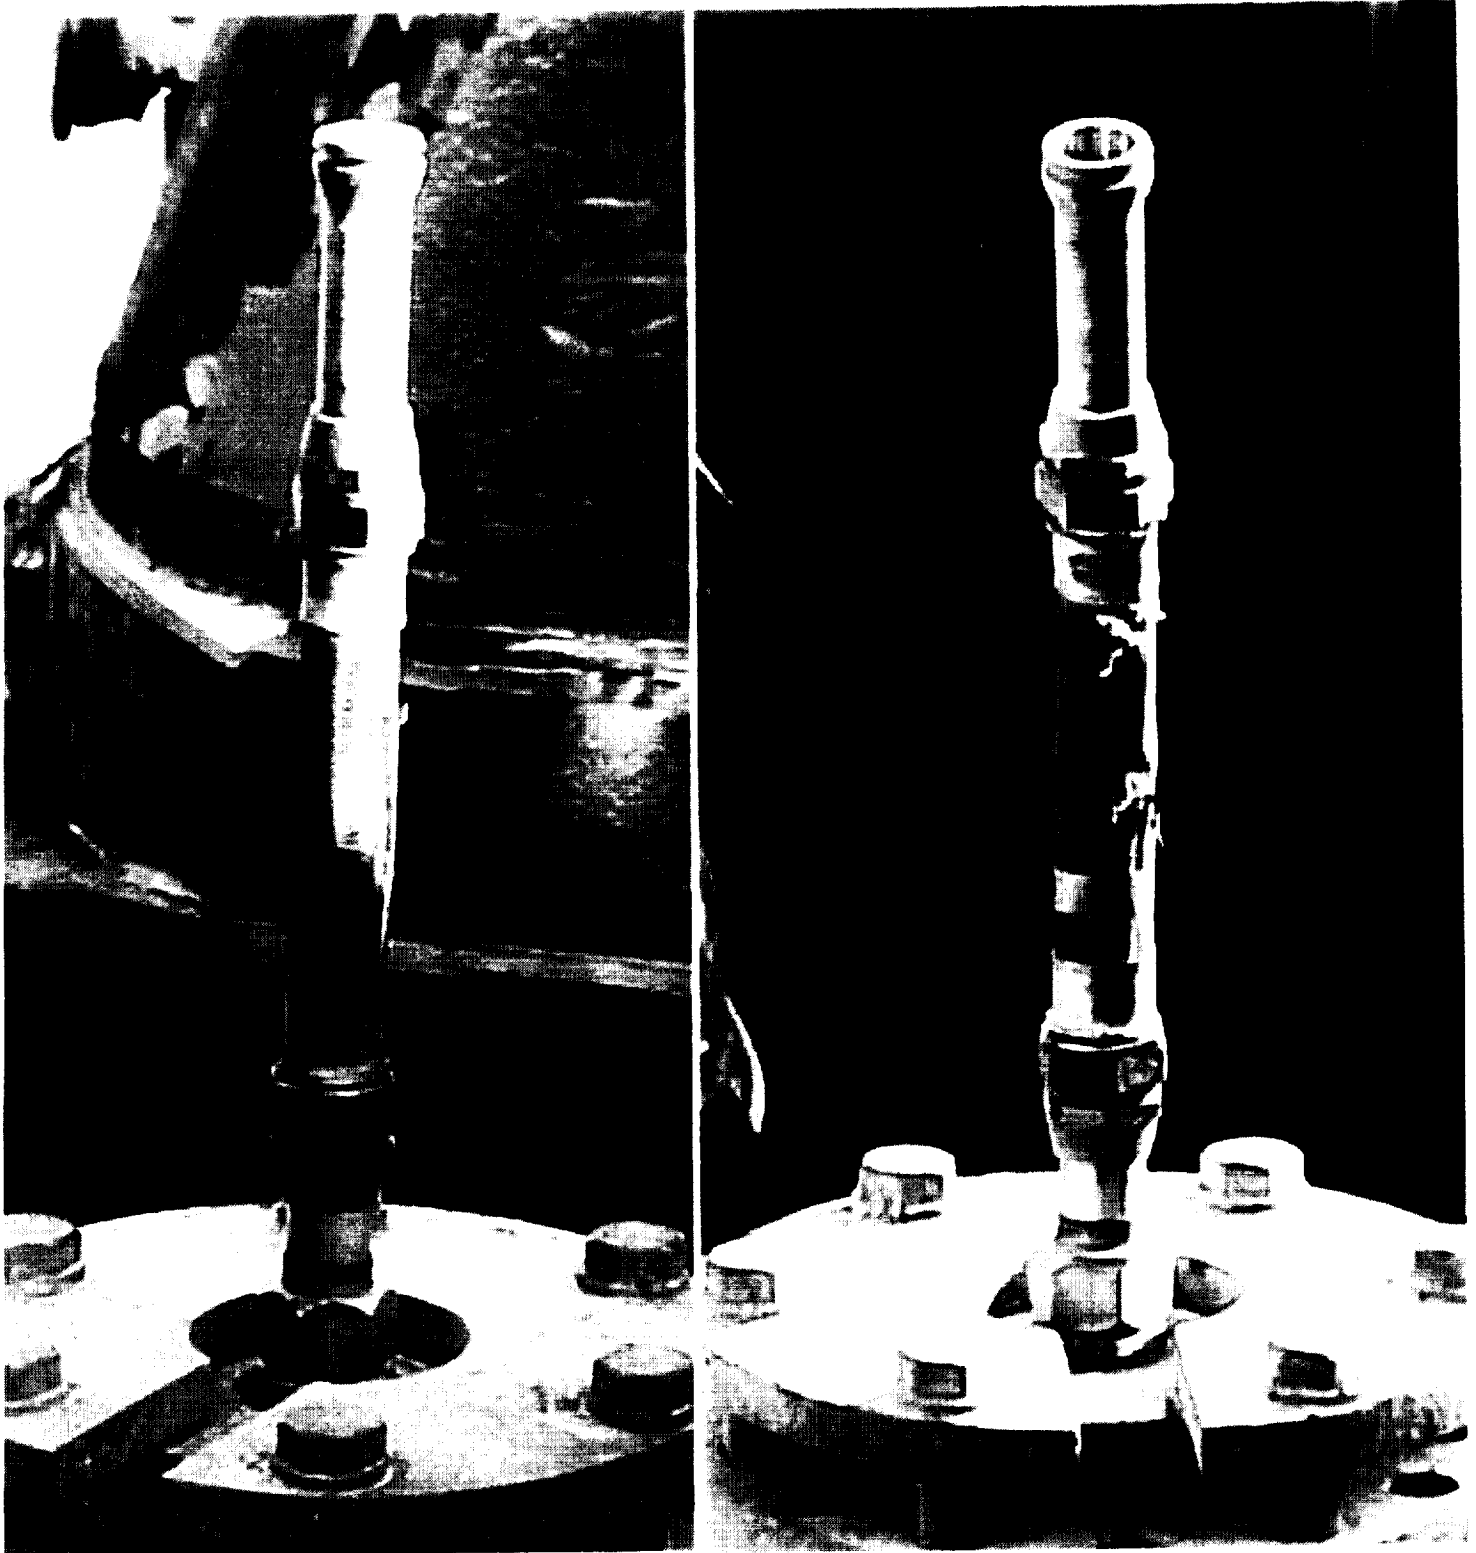
**Photo 12: Aft Skirt GN2 Purge Lines**

Both SRB aft skirt GN2 purge lines were intact, though the protective tape was almost entirely eroded away with minimal damage to the underlying braided shield.

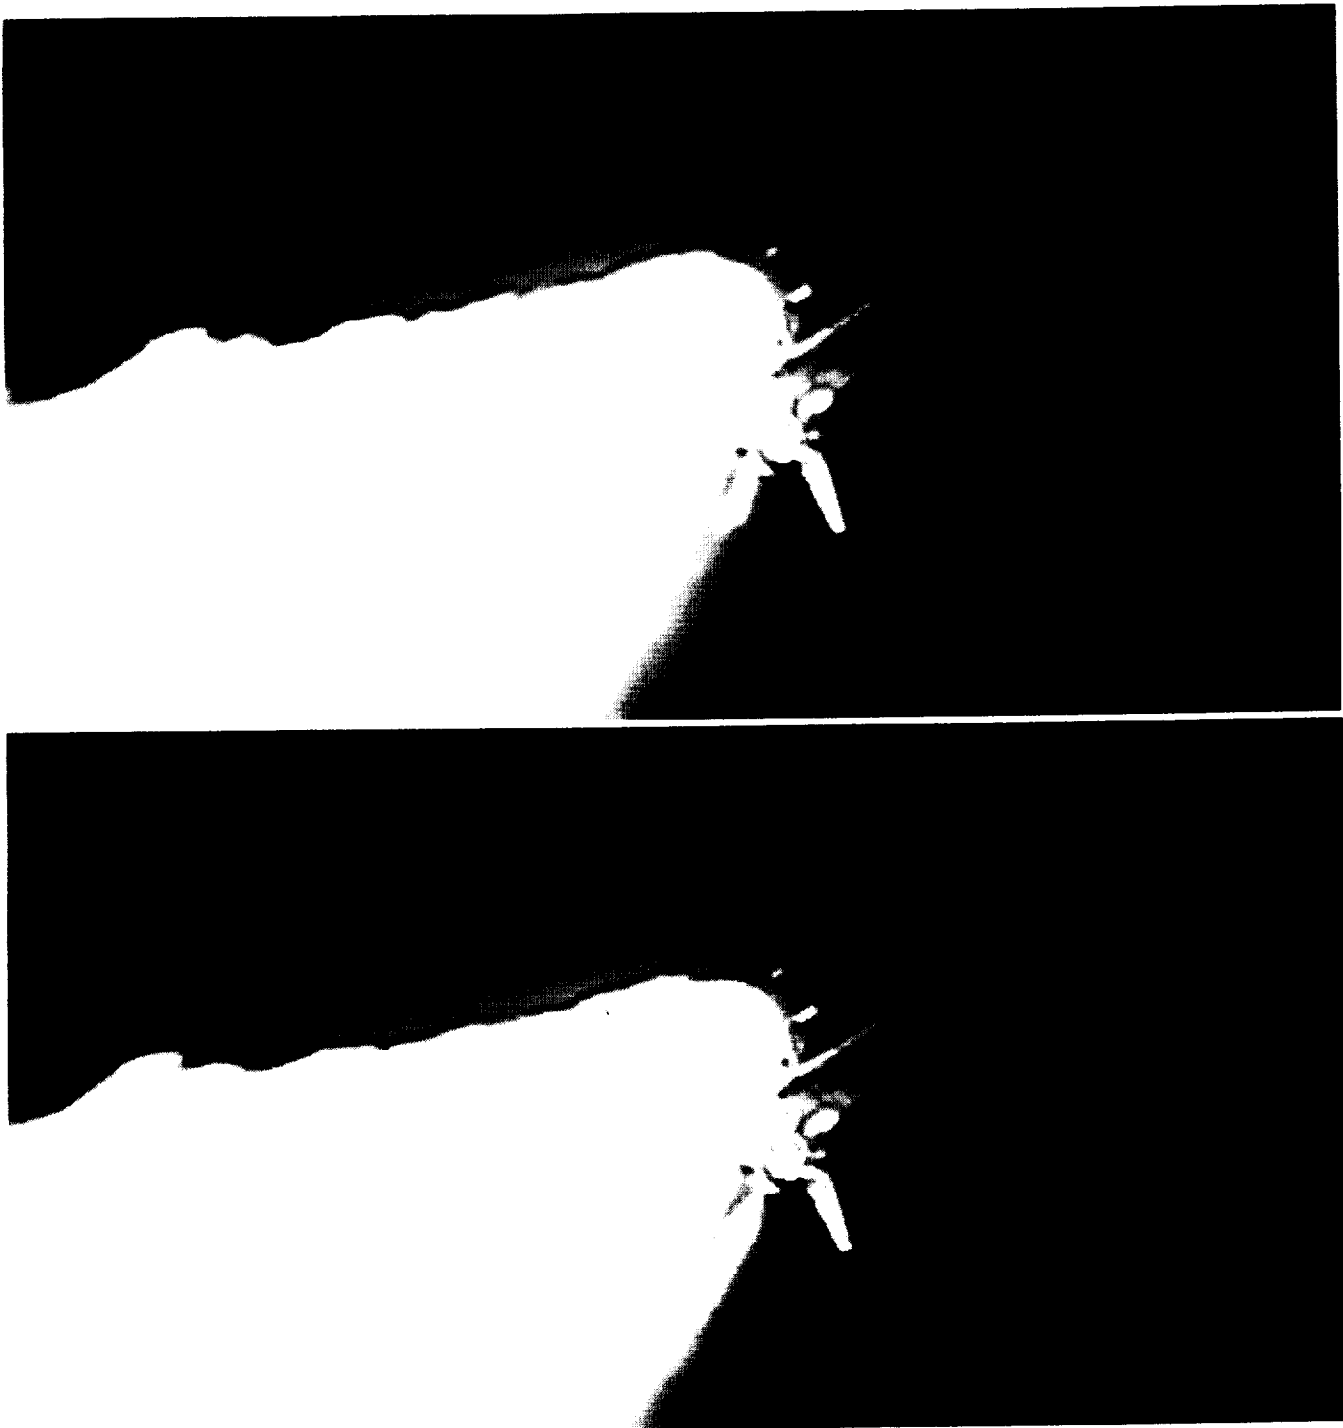
**Photo 17: Large Flash in SSME Plume**

A large flare occurred in the SSME #1 exhaust plume at 53 seconds MET for 0.17 seconds duration. This type of flare is usually caused by debris, such as a particle of SRB aft skirt aft ring instafoam, passing through the exhaust plume.

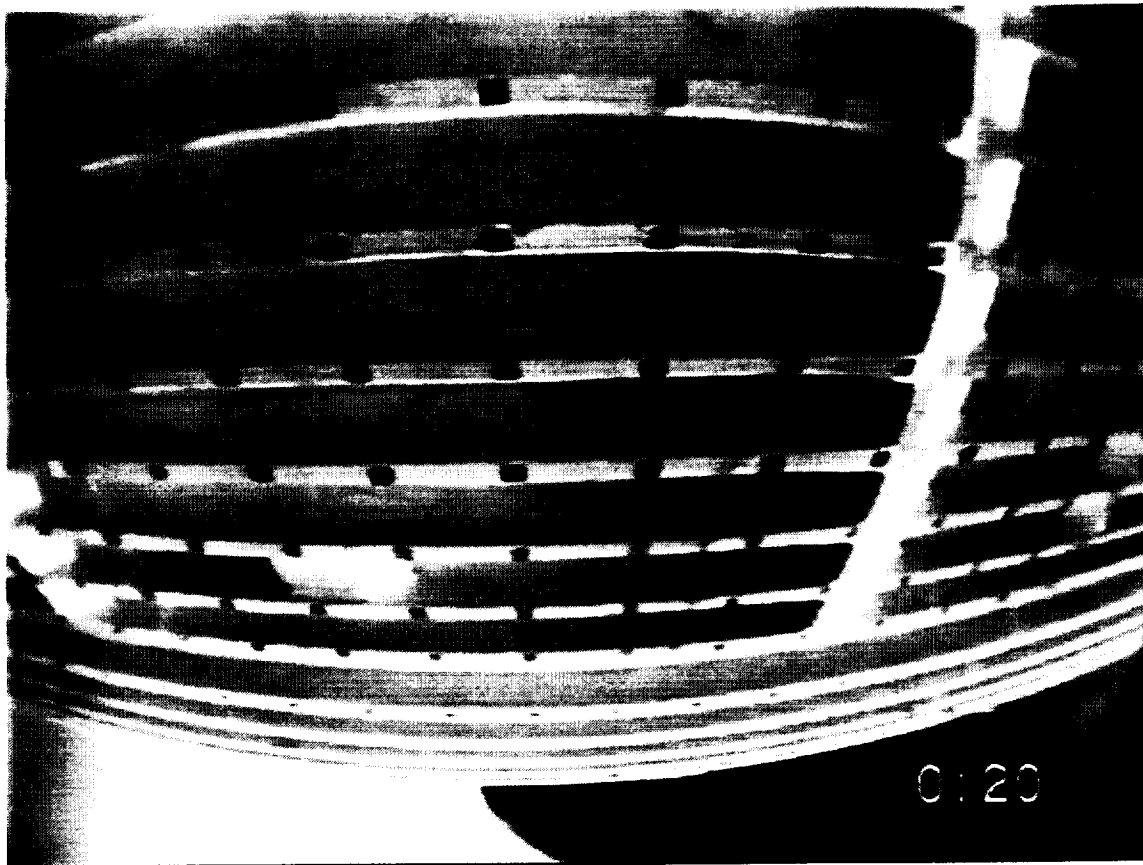
**Photo 19: ET +Y Thrust Panel**

Views of the ET +Y thrust panel at 20 and 123 seconds MET. As expected, divots were smaller in size and fewer in number in the vented areas when compared to the unvented areas (note larger divots in the right side of the frame). Generally, divots in vented areas were less than 0.5 inches in diameter and shallow in depth.

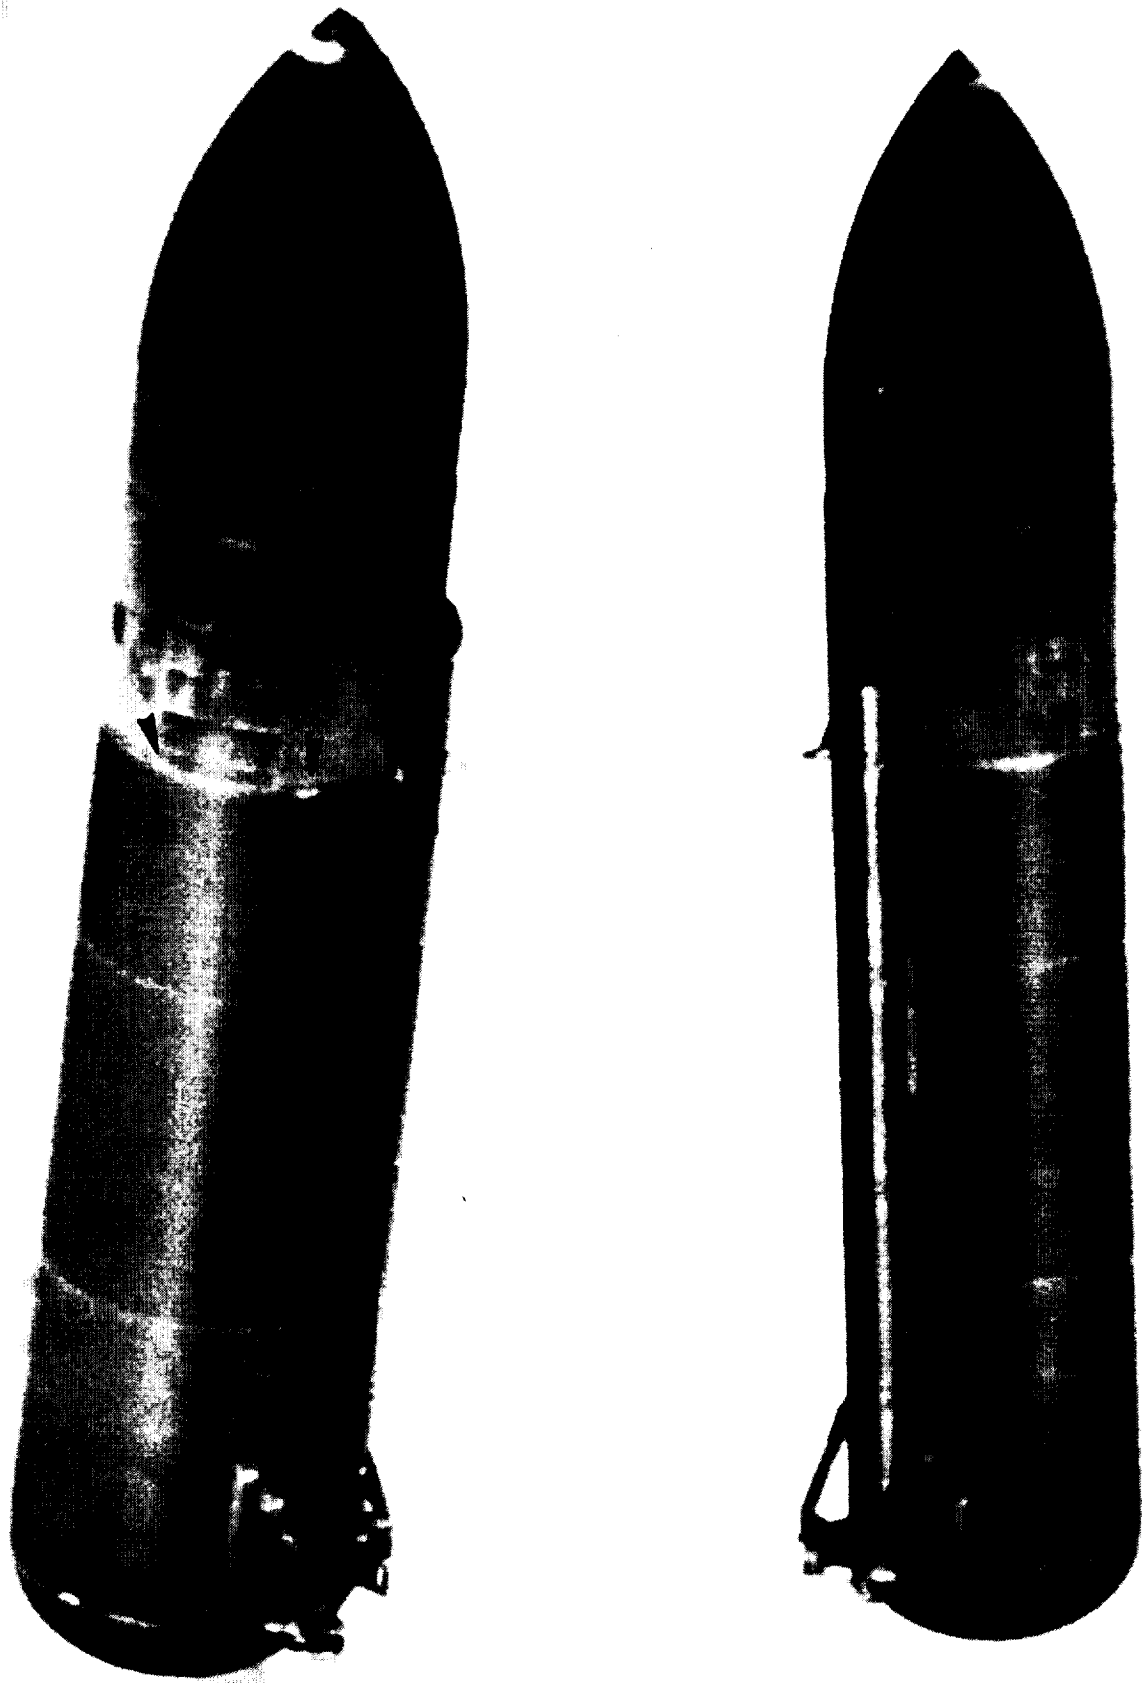
**Photo 25: ET Thrust Panels**

Crew hand held images show no large divots in either thrust panel - that would be discernible with the given image resolution and subject distance. Yet three 9-inch diameter divots are readily visible in the LH2 tank-to-intertank splice (arrows).

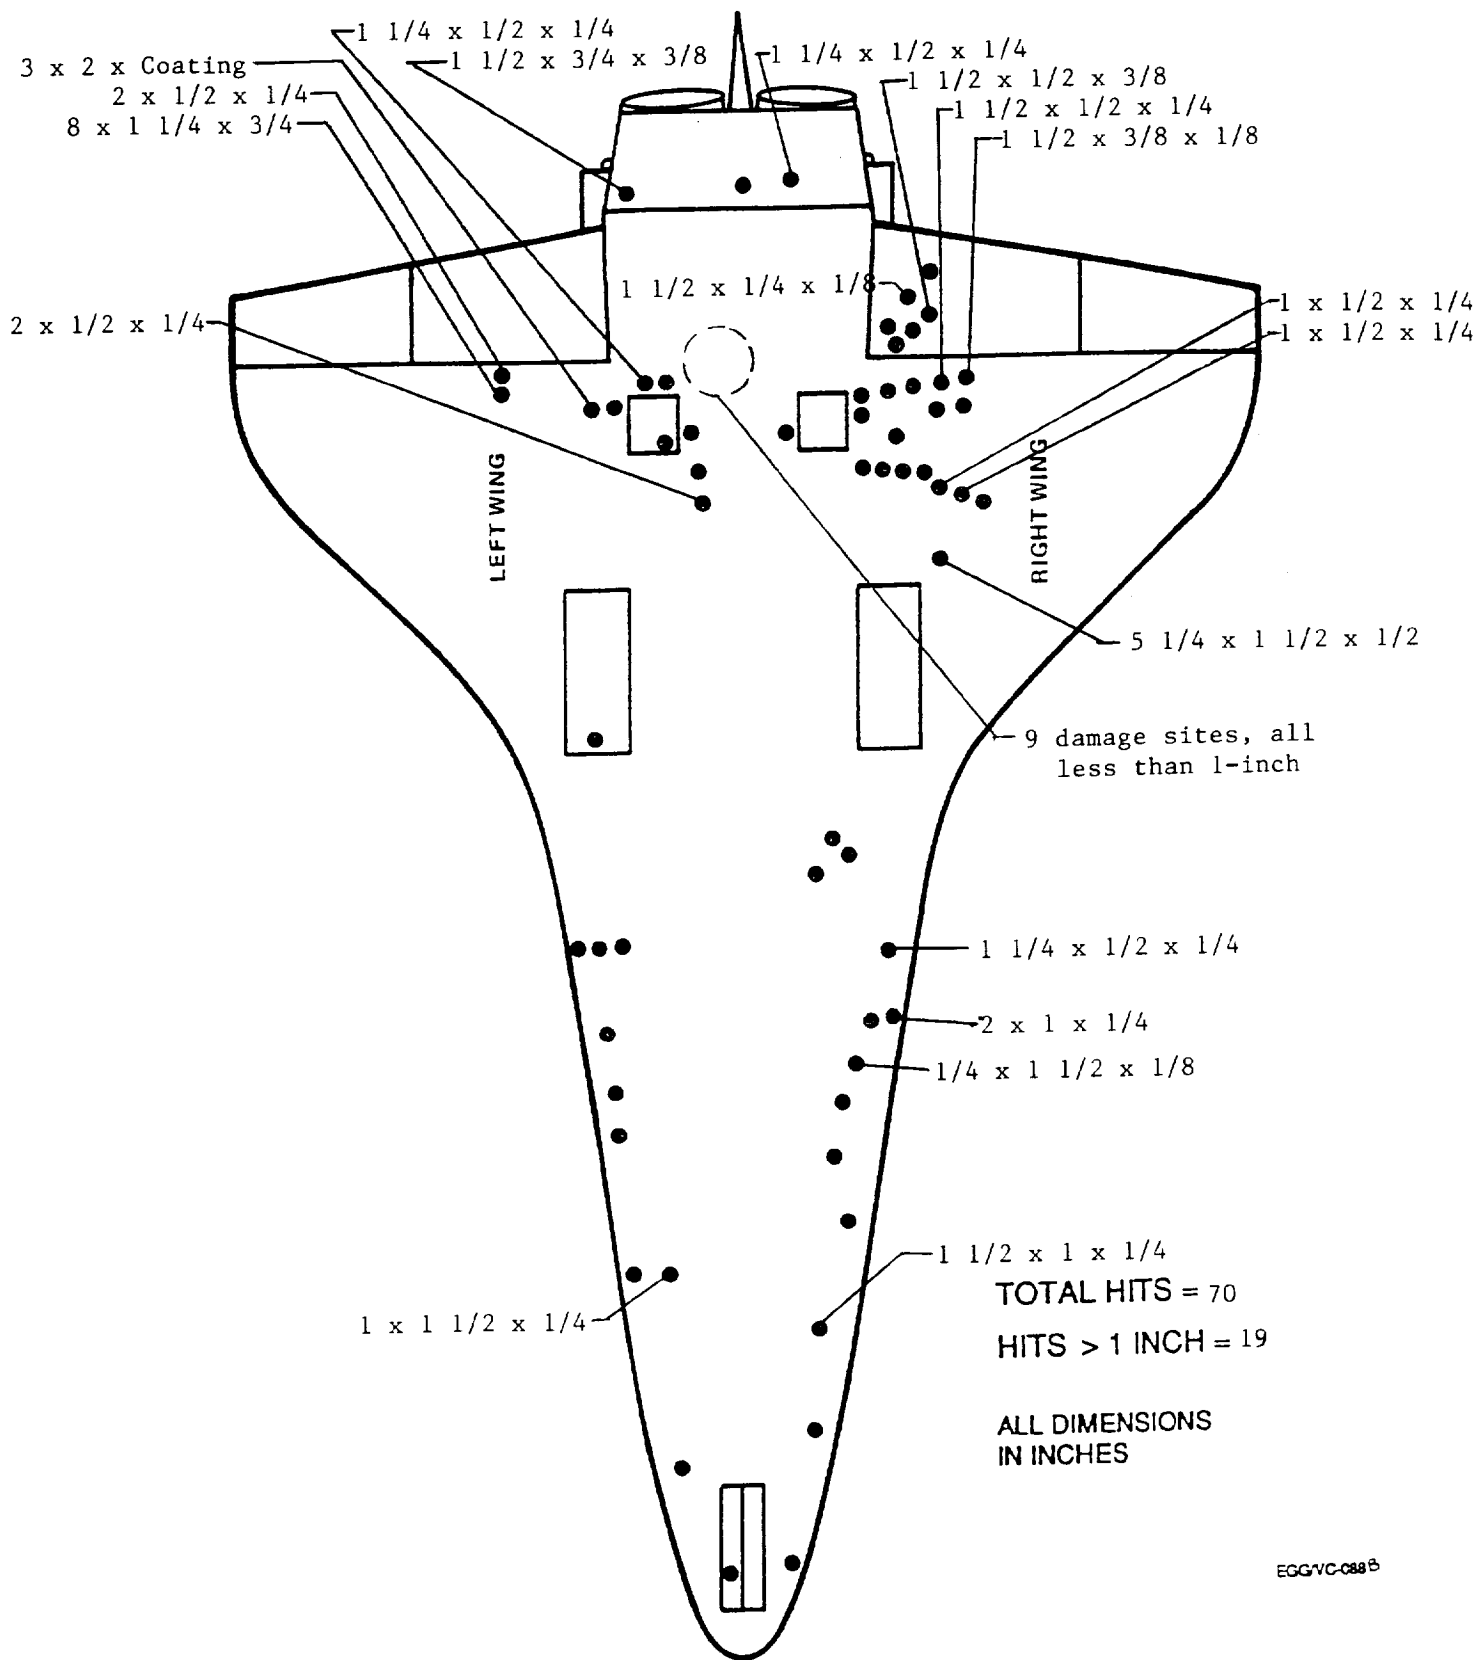
Figure 1: Orbiter Lower Surface Debris Damage Map

Post landing inspection of Orbiter tiles showed a total of 113 hits, of which 27 had a major dimension of 1-inch or larger. The Orbiter lower surface sustained 70 total hits, of which 19 had a major dimension of 1-inch or larger. Some of these damage sites (23 hits with five larger than 1-inch) were located in the area from the nose gear to the main landing gear wheel wells on both left and right chines, which is consistent with the loss of foam from ET thrust panels. But the overall quantity and average size of the damage sites compared to previous flights were consequently reduced as a result of the pre-launch TPS venting modification. And some of the hits in this area may also be attributed to impacts from LO2 feedline bellows ice particles.

The largest lower surface tile damage site, located on the left wing immediately forward of the inboard elevon hinge, measured 8-inches long by 1.25-inches wide by 0.75-inches deep. The cause of this damage site has not been determined. However, it should be noted the damage site typically erodes during re-entry and may have initially been considerably smaller than the size listed above. Referencing the Debris Trajectory Database showed potential points of origin on the forward and mid segments of the left SRB, so it is possible a small piece of cork or BTA may have come loose in flight.

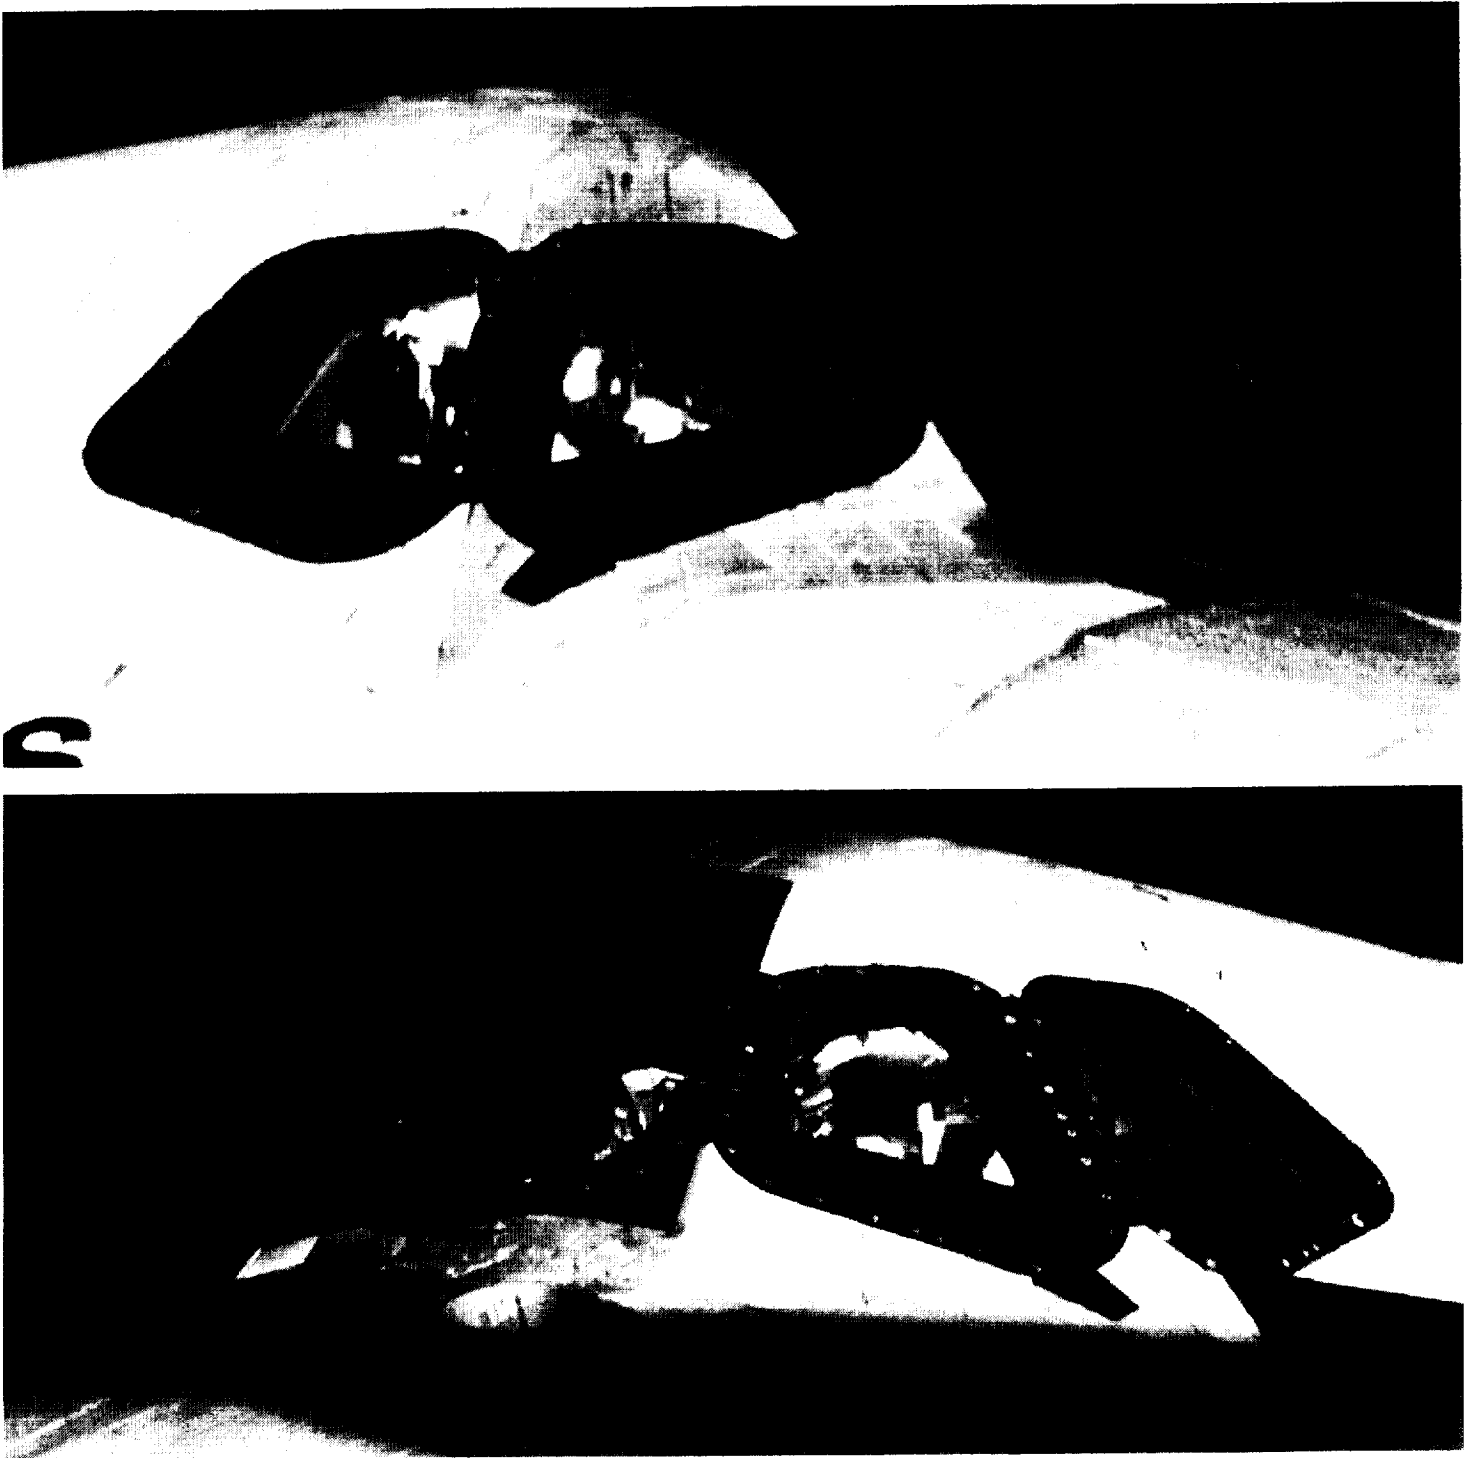
**Photo 33: Windows**

Damage sites on the window perimeter tiles was less than usual in quantity and size. Hazing and streaking of forward-facing Orbiter windows was moderate. The largest damage site, located in window #2 perimeter tiles, was approximately 1.5-inches long by 0.75-inches wide. This damage may be attributed to impacts from FRCS thruster paper covers and RTV adhesive.

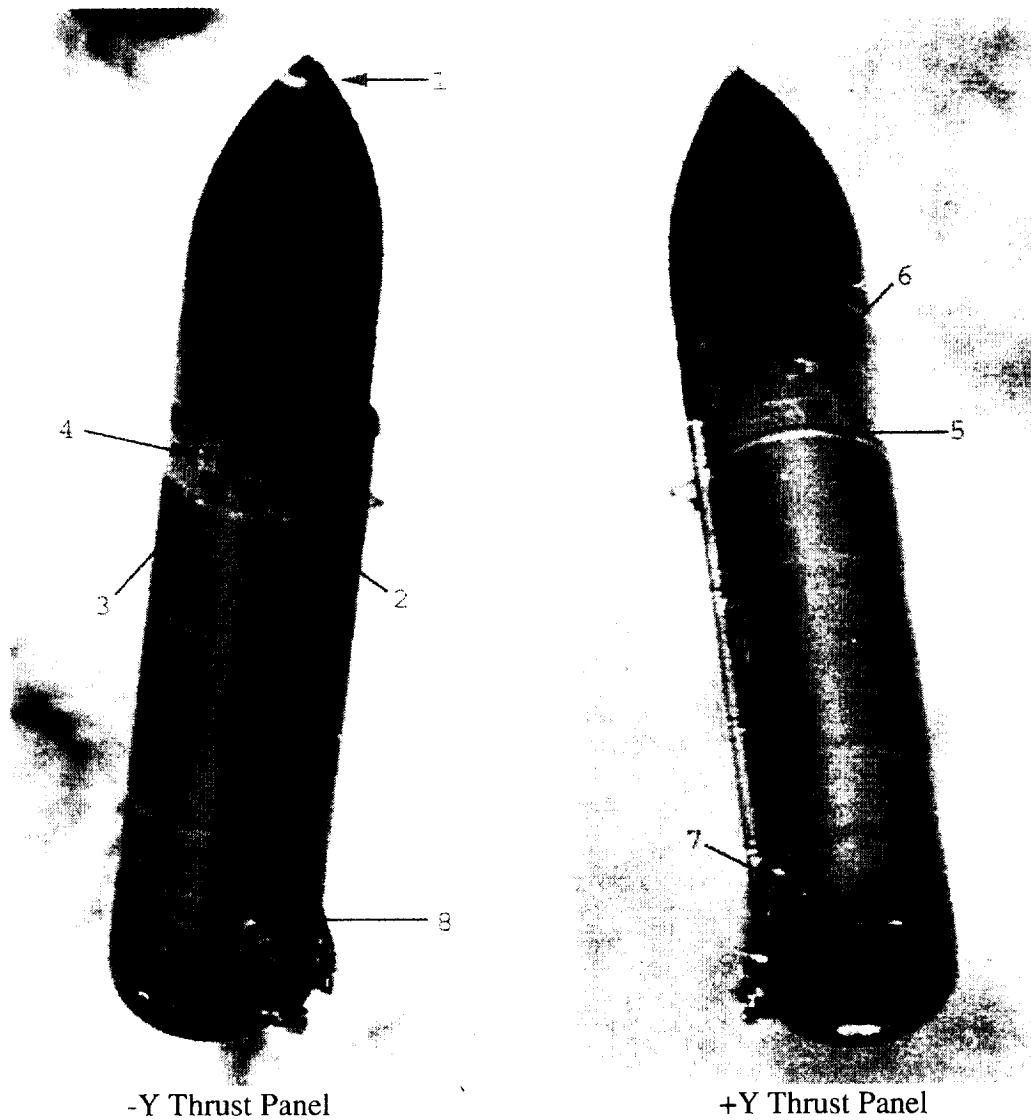
Figure 2.5.2(A) Handheld ET Views

The normal SRB separation burn scars and aero-heating marks were noted on the intertank and nose TPS of the ET. See Figure 2.5.2(A). In addition, the following items were noted:

- Three large appearing light-colored areas were noted on the -Y thrust panel in the -Y direction from the LSRB forward attach fitting. (On the LSRB thrust panel video, there is an indication of possible small divots on several rib heads in one of these three areas that could be seen during SRB separation.) (Figure 2.5.2(A) annotation #4)

- Three light-colored areas were detected on the +Y thrust panel in the +Y direction from the RSRB forward attach fitting. These light-colored areas may be caused by areas of TPS erosion or clusters of divots too small to resolve on the handheld film. (Figure 2.5.2(A) annotation #6)

- A light-colored mark (possible divot) was seen on the forward left corner of the -Y longeron. (Figure 2.5.2(A) annotation #8)

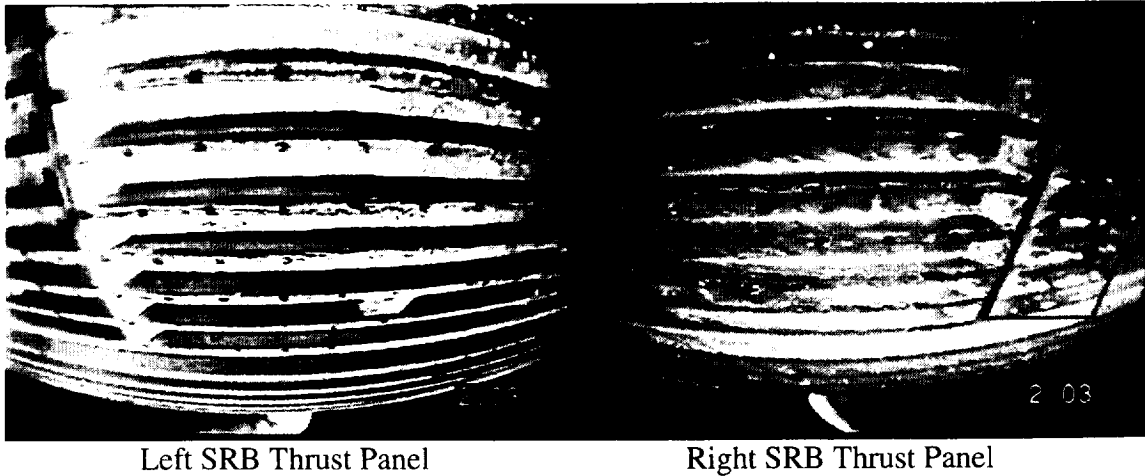
Figure 2.6 (A) ET Thrust Panel Views Prior to Separation

Figure 2.6(A) contains views of the STS-101 ET Thrust Panels just before SRB separation (2:03 seconds MET). After separation, there were a large number of divots visible in the unvented area of the right ET thrust panel aft and in the -Y direction from the RSRB attach fitting (area outlined in red on the right SRB thrust panel view). The largest of these divots were estimated to be less than 5-inches in diameter. Six divots were seen on a right thrust panel circumferential rib (station XT-1058). A seventh divot was seen on the same circumferential rib in the +Y direction closer to the +Y intertank.

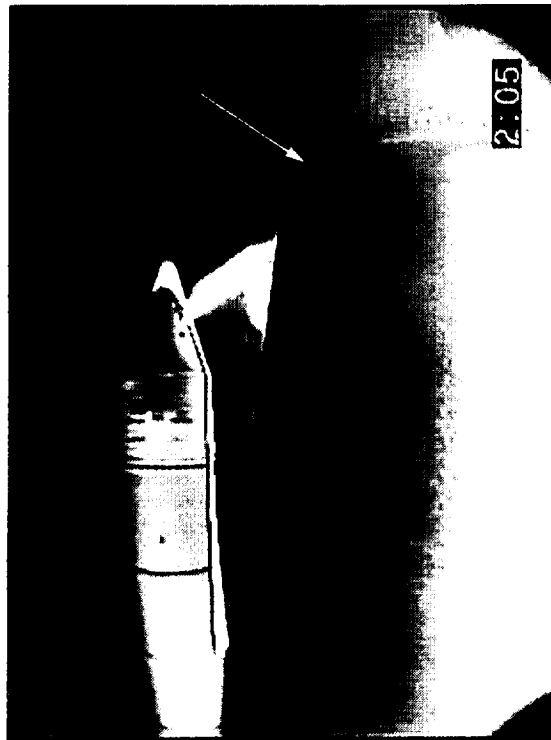
Figure 2.6(B) Divot on -Y LH2-to-intertank Flange Closeout

An approximate 9-inch divot was seen on the -Y LH2-to-intertank flange closeout and the LH2 tank interface aft of the intertank access door (Figure 2.6(B)).

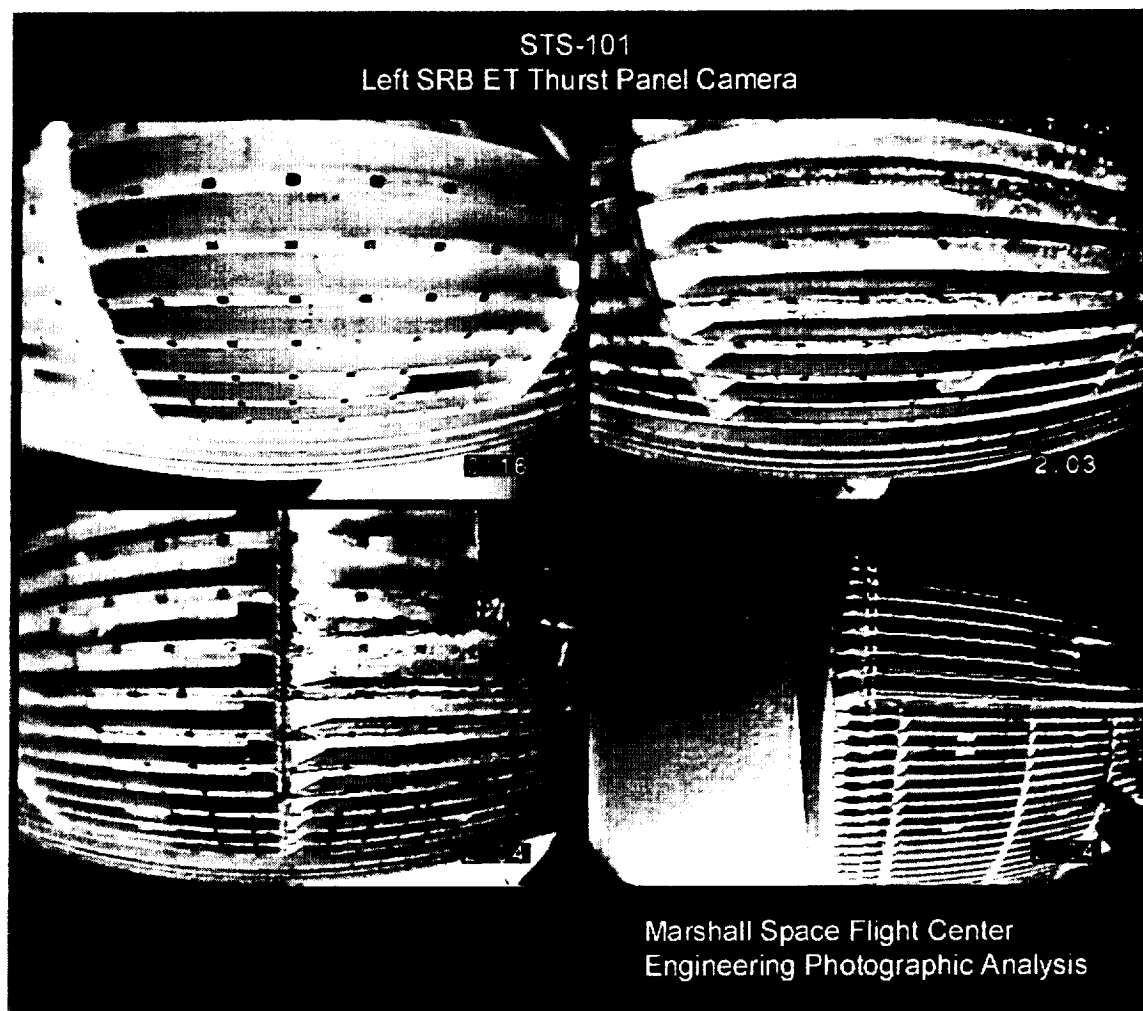
Figure 6. Left SRB Video Camera

Views of the External Tank from the left Solid Rocket Booster Video Camera early (0:16), just before (2:03) and just after (2:04) separation from vehicle, showing a progression of the condition of the Thermal Protective Surface on the -Y Thrust Panel.

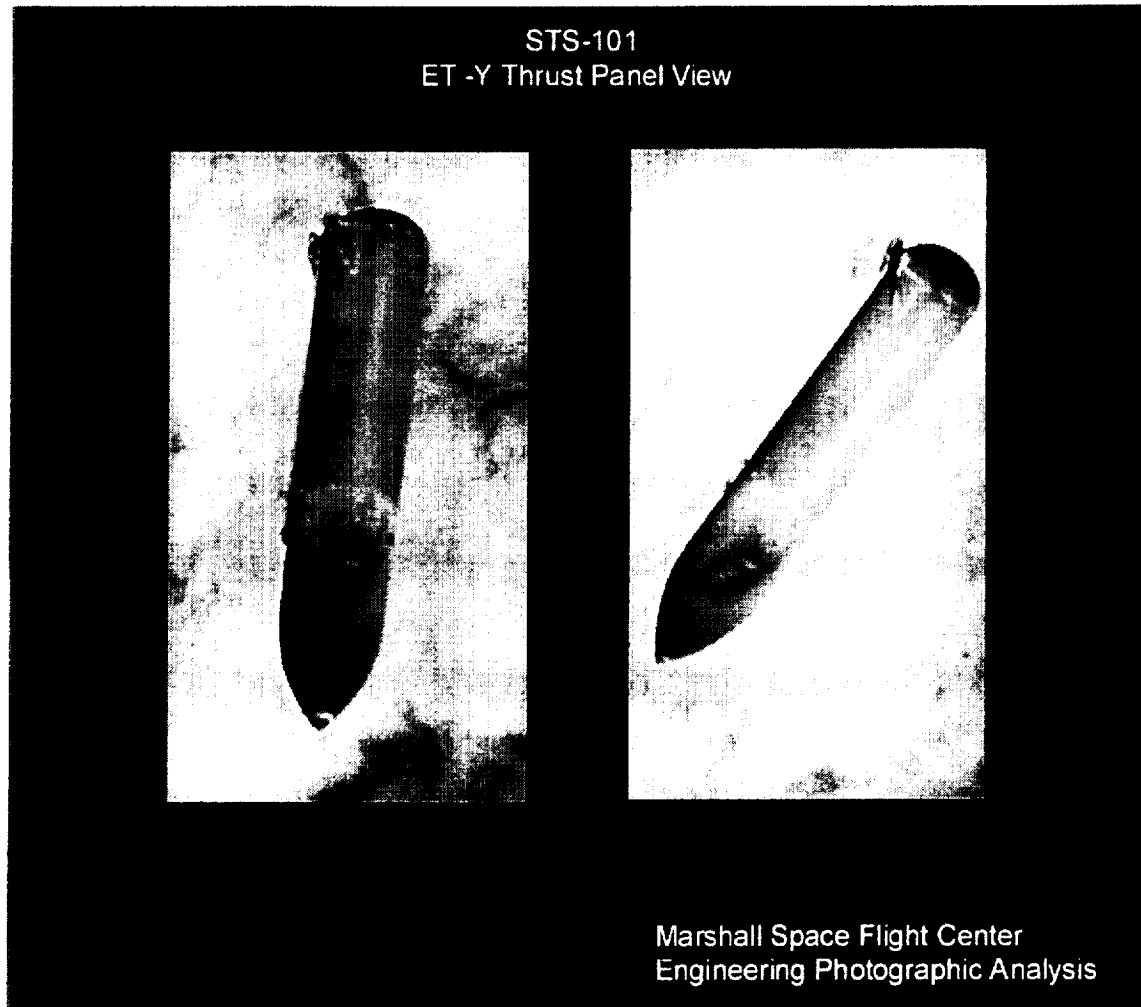
**Figure 8. View of -Y side of the ET from On-board 35mm Hand-held Camera**

Views of the -Y side of External Tank (ET) after separation from vehicle, showing the condition of the Thermal Protective Surface (TPS). No obvious or large scale TPS divoting is observed, scarring of TPS from BSM motor firing appears normal.

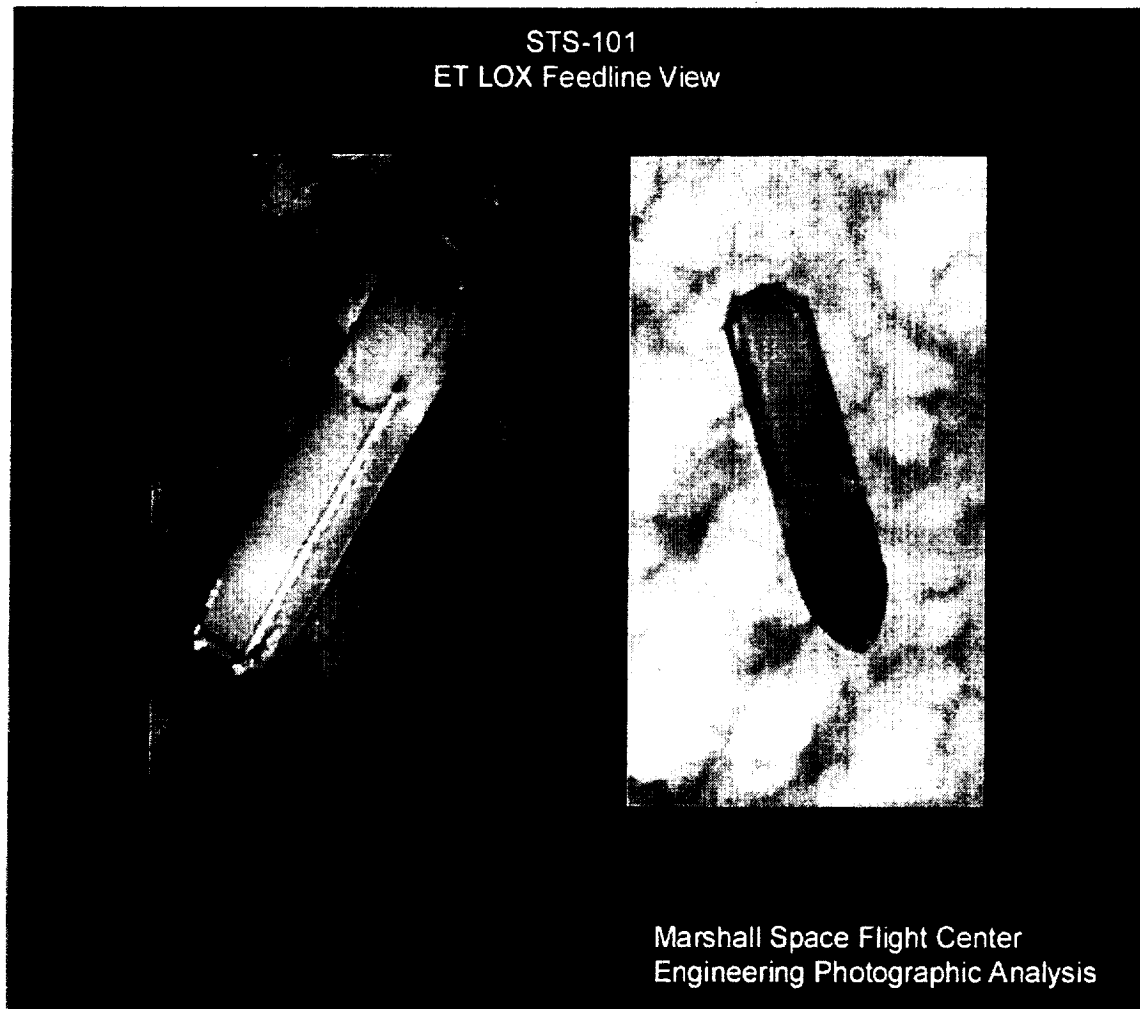
**Figure 9. View of Top Side of the ET from On-board 35mm Hand-held Camera**

Views of the top side of External Tank (ET) after separation from vehicle, showing the LO2 Feedline and the condition of the Thermal Protective Surface (TPS). No obvious or large scale TPS divoting is observed, scarring of TPS from BSM motor firing appears normal.

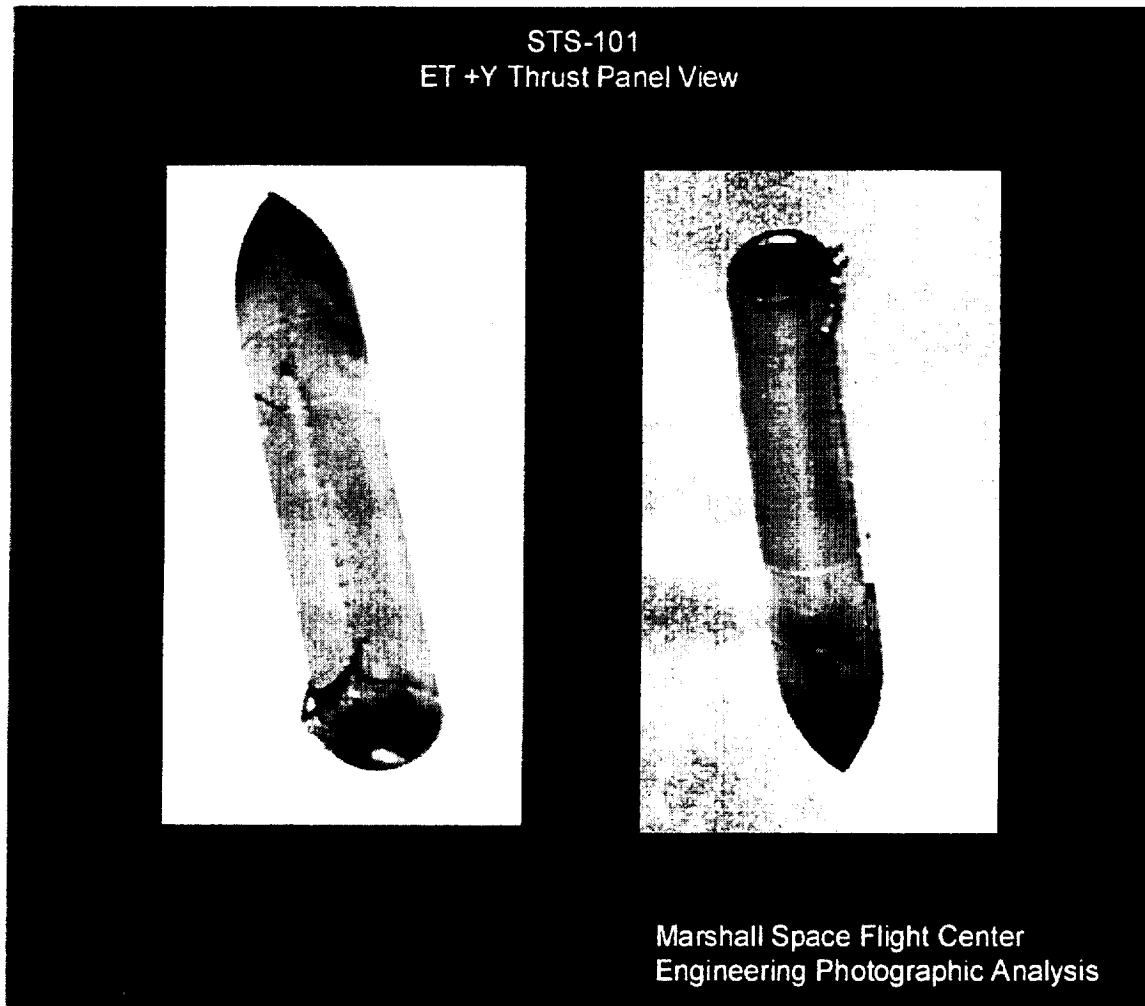
**Figure 10. View of -Y side of the ET from On-board 35mm Hand-held Camera**

Views of the +Y side of External Tank (ET) after separation from vehicle, showing the condition of the Thermal Protective Surface (TPS). No obvious or large scale TPS divoting is observed, scarring of TPS from BSM motor firing appears normal. Charring of the TPS on the aft dome of the LOX tank appears normal.

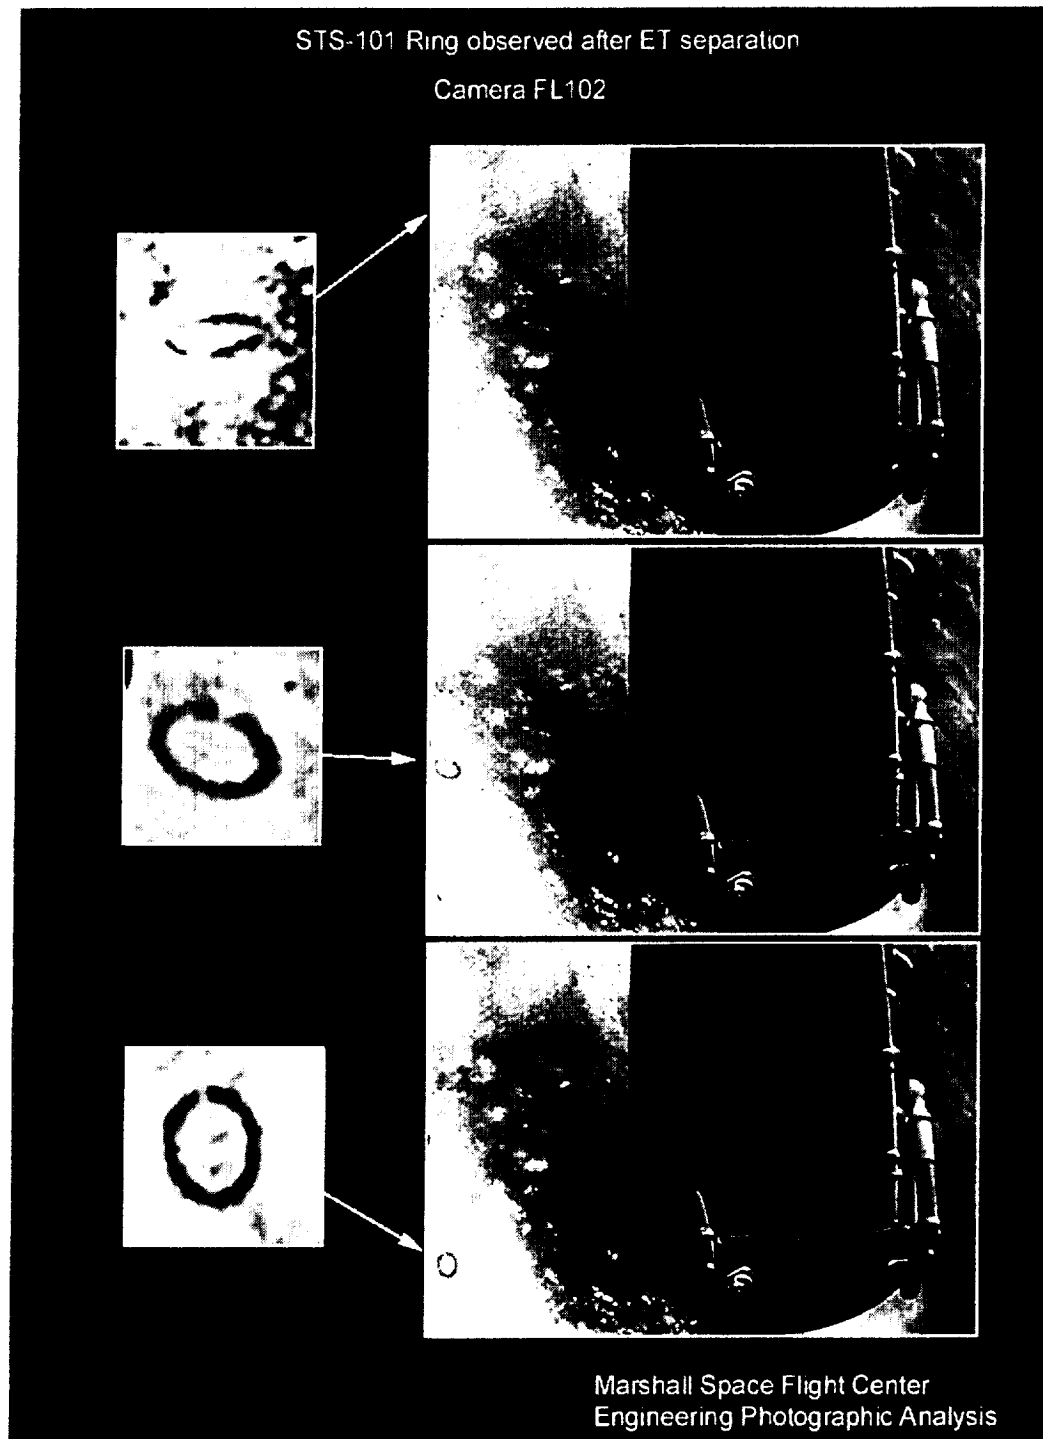
**Figure 11. Ring shaped Debris Object Observed After SRB Separation**

A ring-shaped debris object was noted moving from top to bottom of the field of view after SRB separation. The object was out of focus, indicating that it was near the camera, rather than the ET. It is suspected that the object is an O-ring from one of the 17" disconnects.

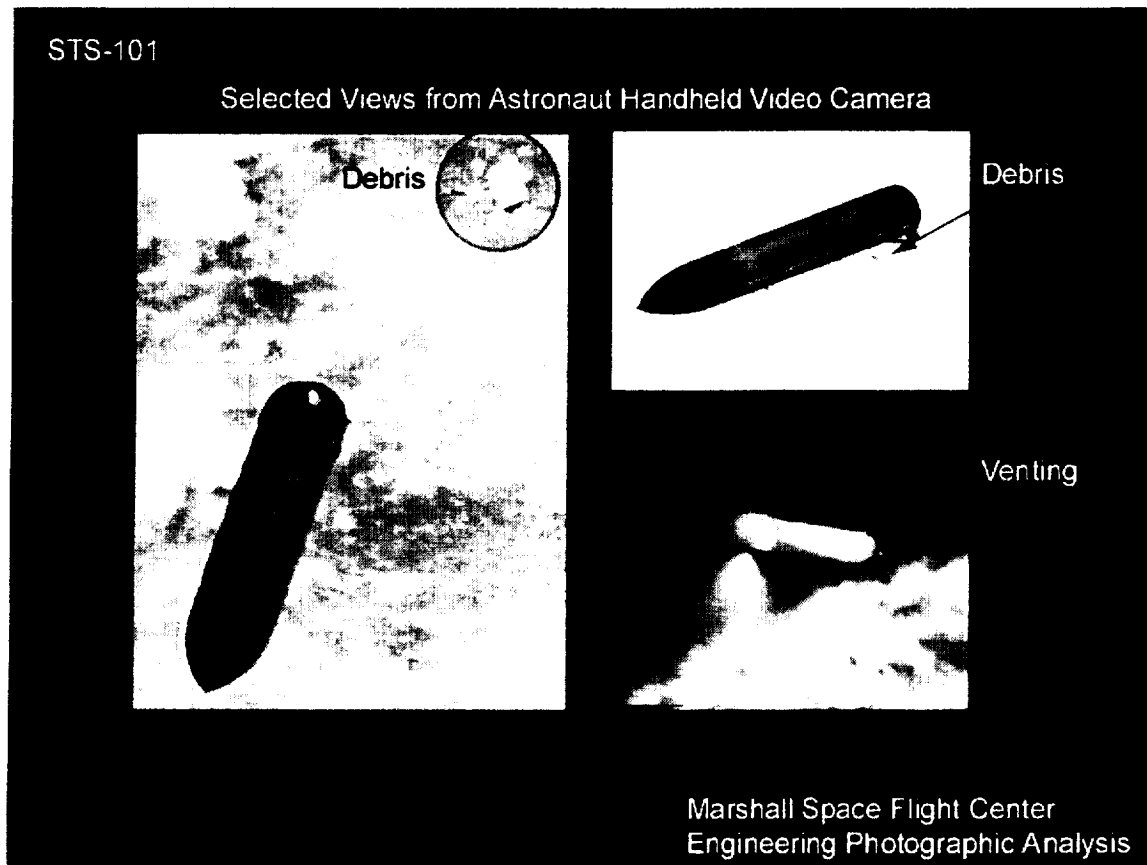
**Figure 12. Selected Views from the Astronaut Hand Held Video**

Two conspicuous debris objects were observed from the astronaut hand held video. One was an odd shaped debris item, noted in the upper right corner of the left hand frame below and appears to be ice. The other debris object is most likely ice floating between the camera and the ET. Typical GUCP venting was also observed.
